# Source and upper catchment of River Rwizi

## *Buhweju District, Uganda*

Field observations, hydrological flow, land use, conservation and photographic documentation. Prepared for RWIZI Organisation, August 2026.

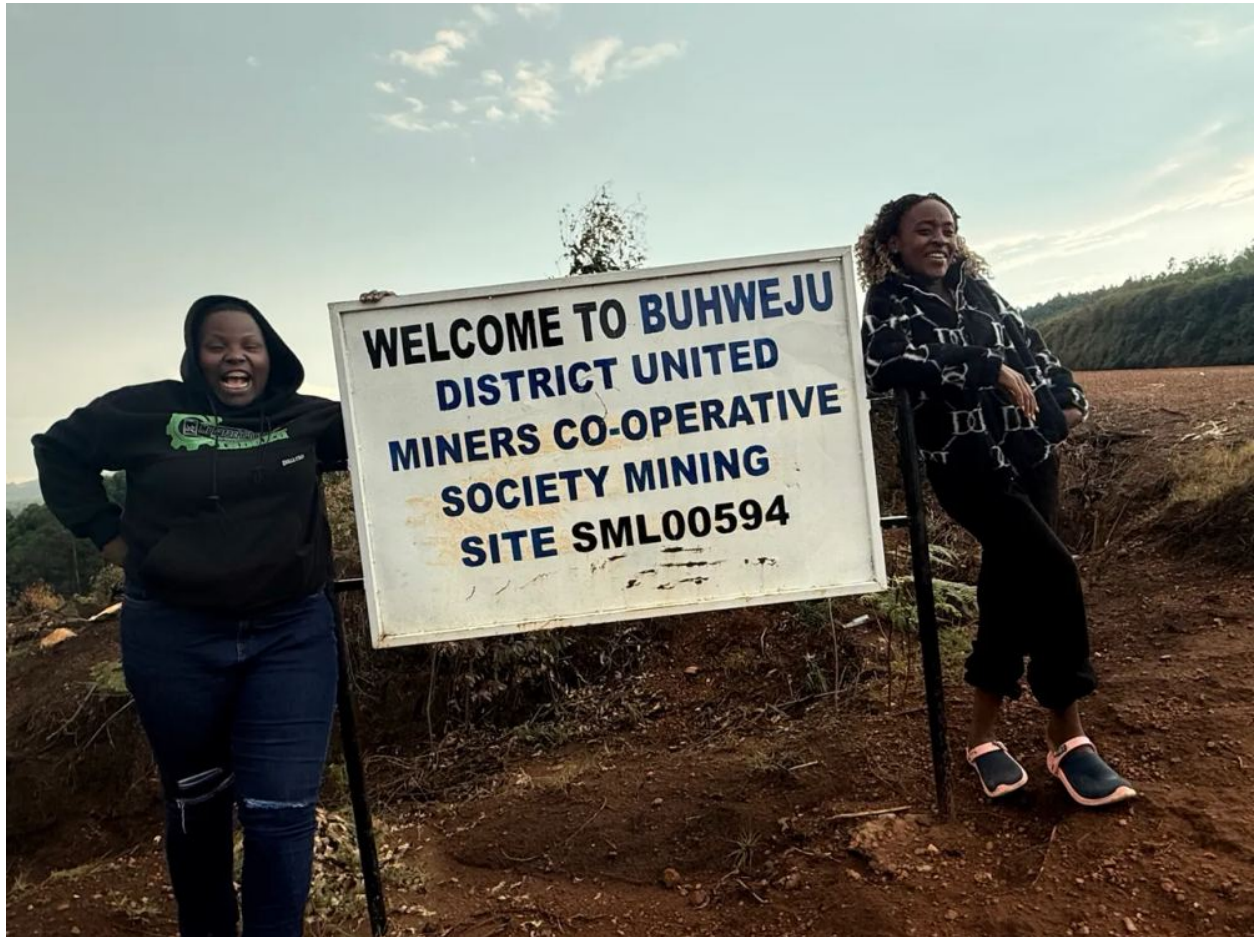
**5.5 Mining and Human Activities** The mining-site photograph documents mining-related land use. In March 2026, the Ministry reported engagement with the gold-mining community in Buhweju concerning silting and pollution of River Rwizi and the need for environmentally friendlier mining methods.

Buhweju District United Miners Co-operative Society sign, mining site SML00594.

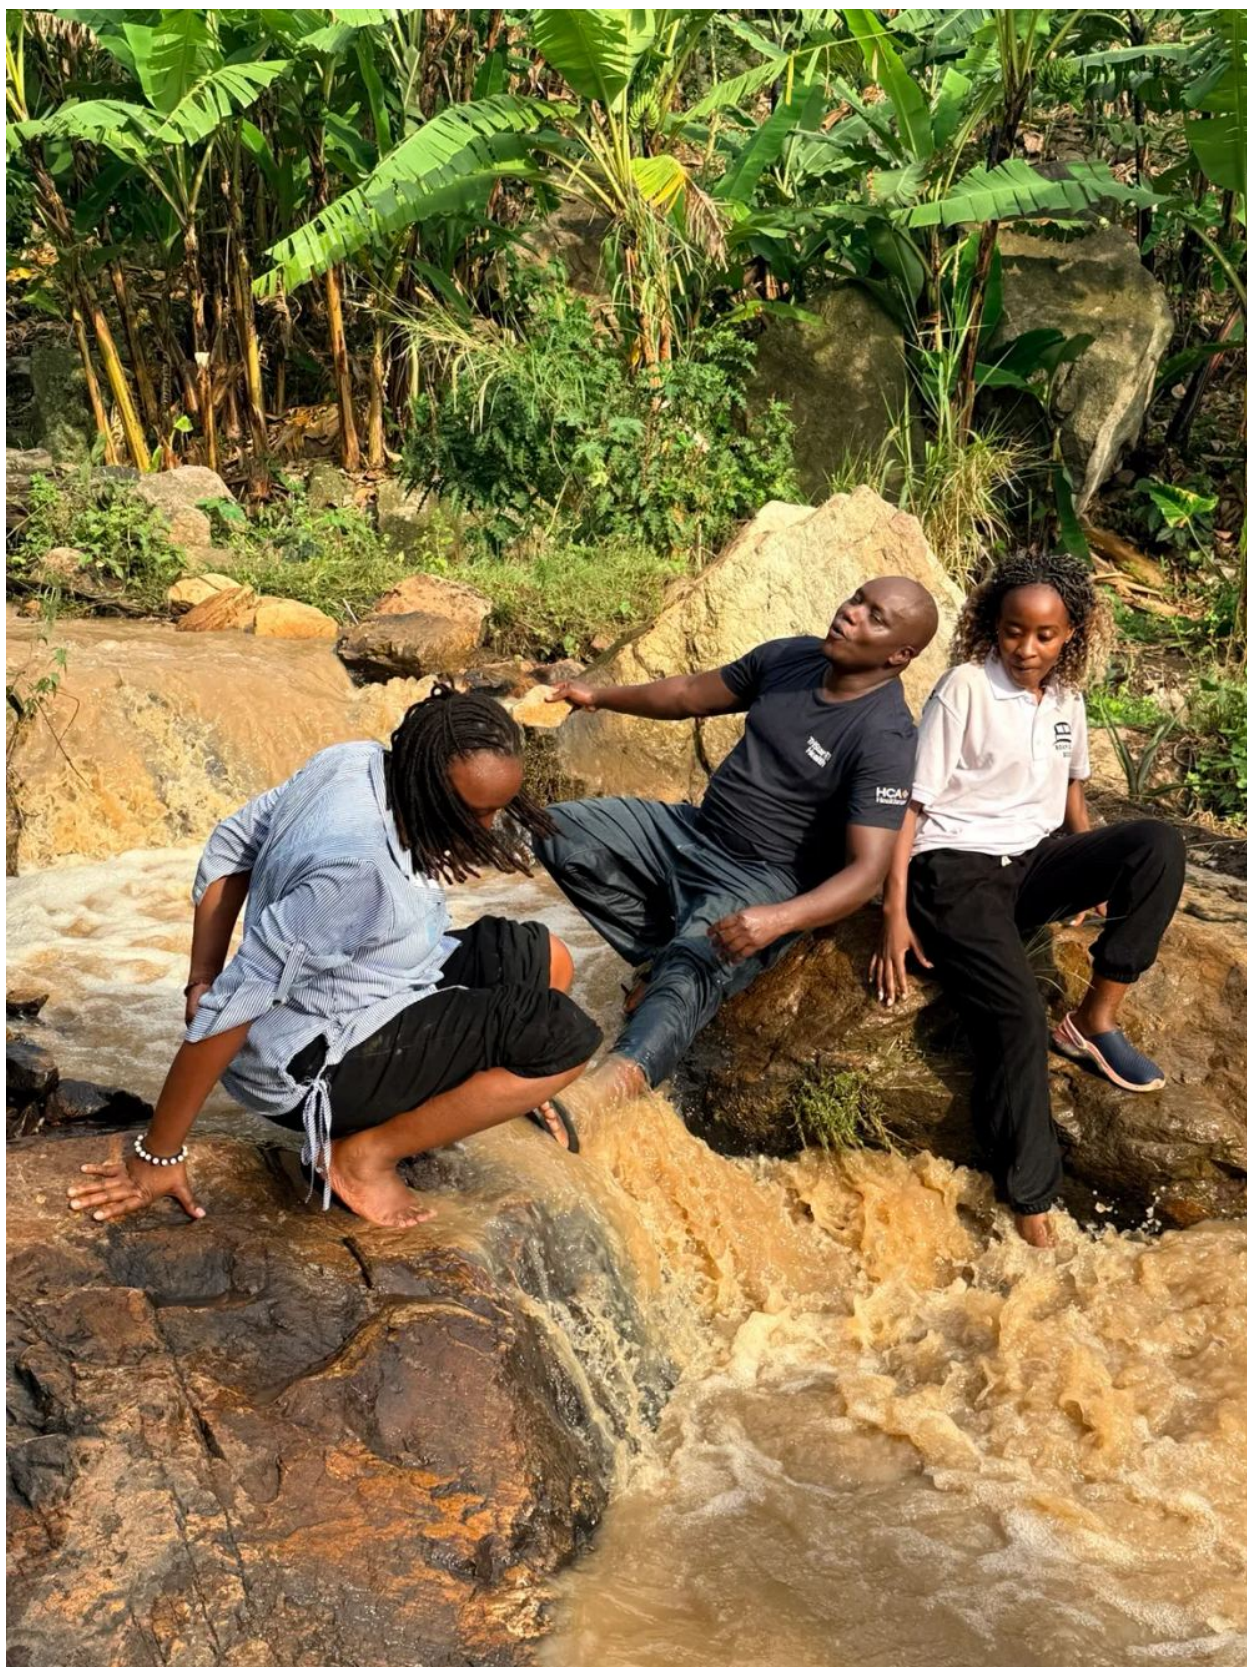
**5.2 Flowing Water and Waterfalls** Flowing water was observed in the upper catchment. The waterfall photograph provides visual evidence of water moving through a rocky section of the landscape.

The field team at a stream below the source, the water running brown.

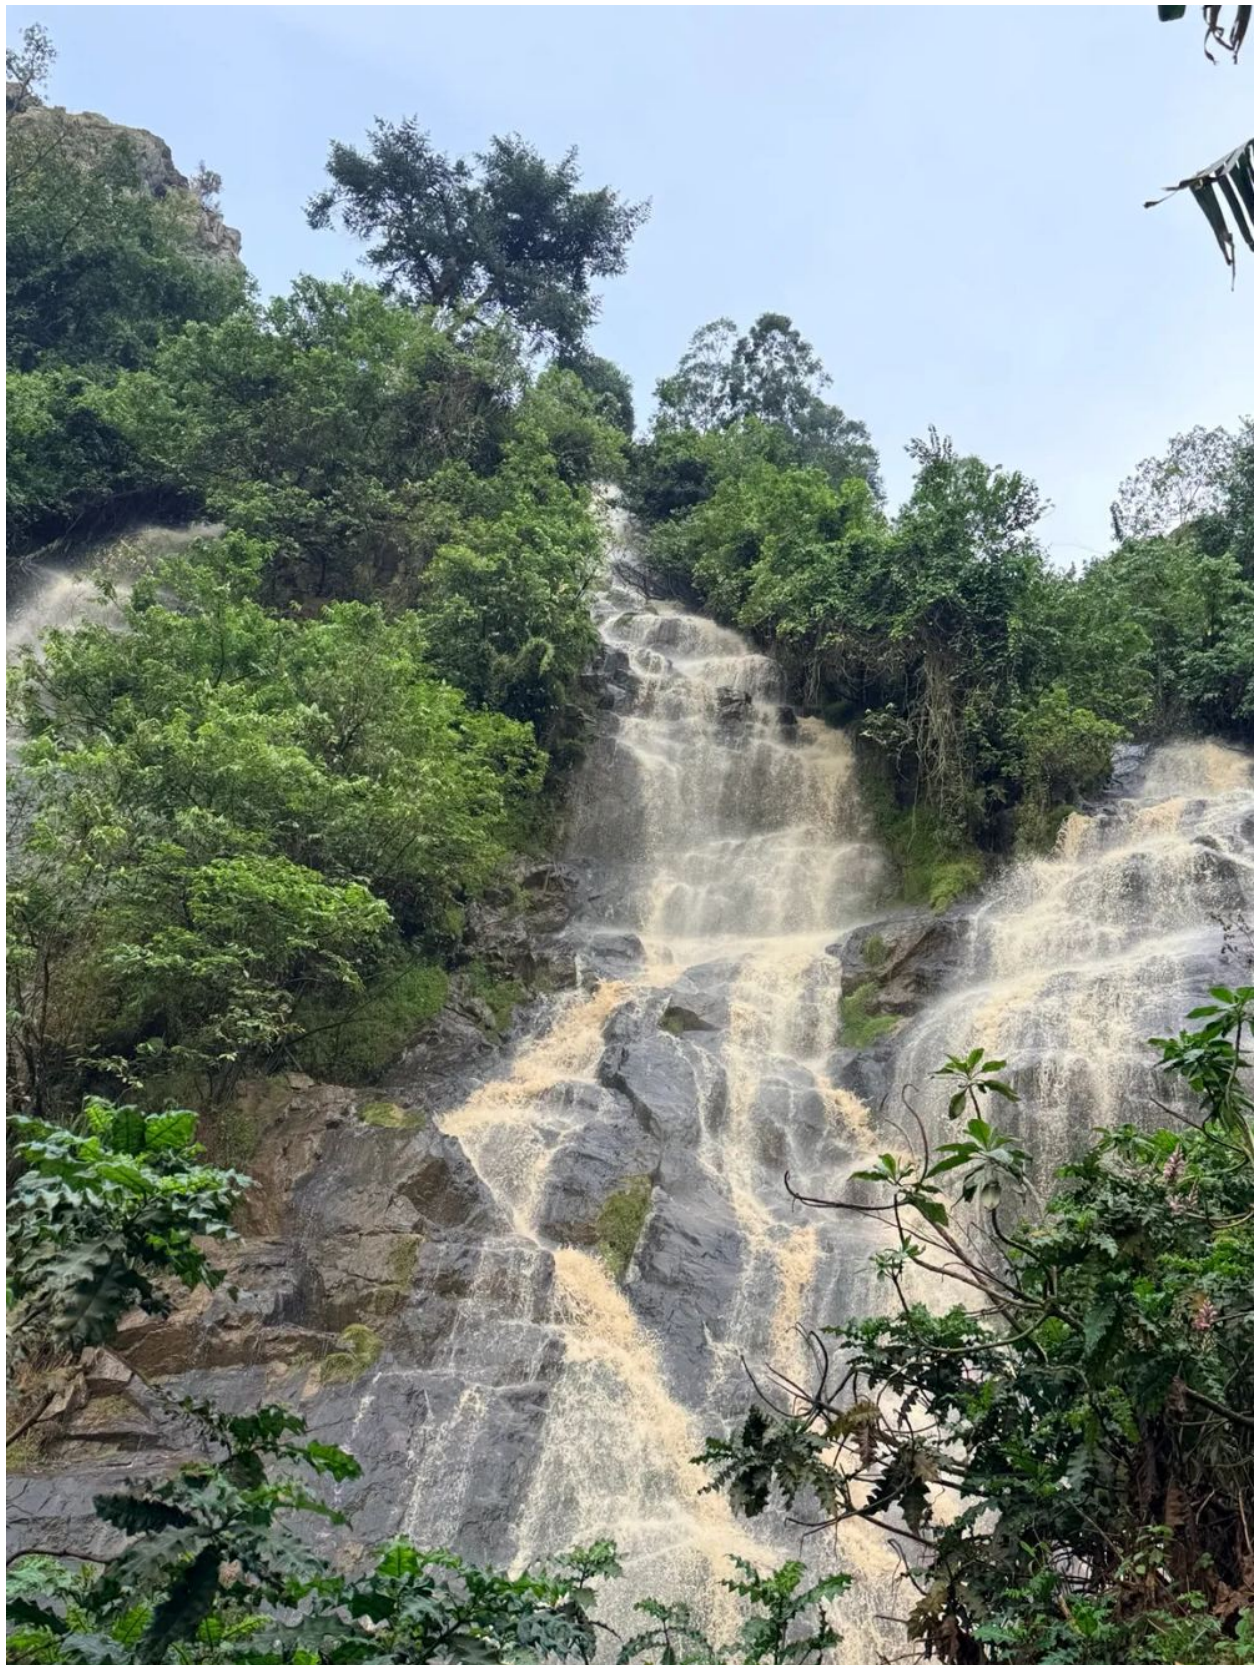
Waterfall in the Buhweju upper catchment, carrying sediment off the slopes.

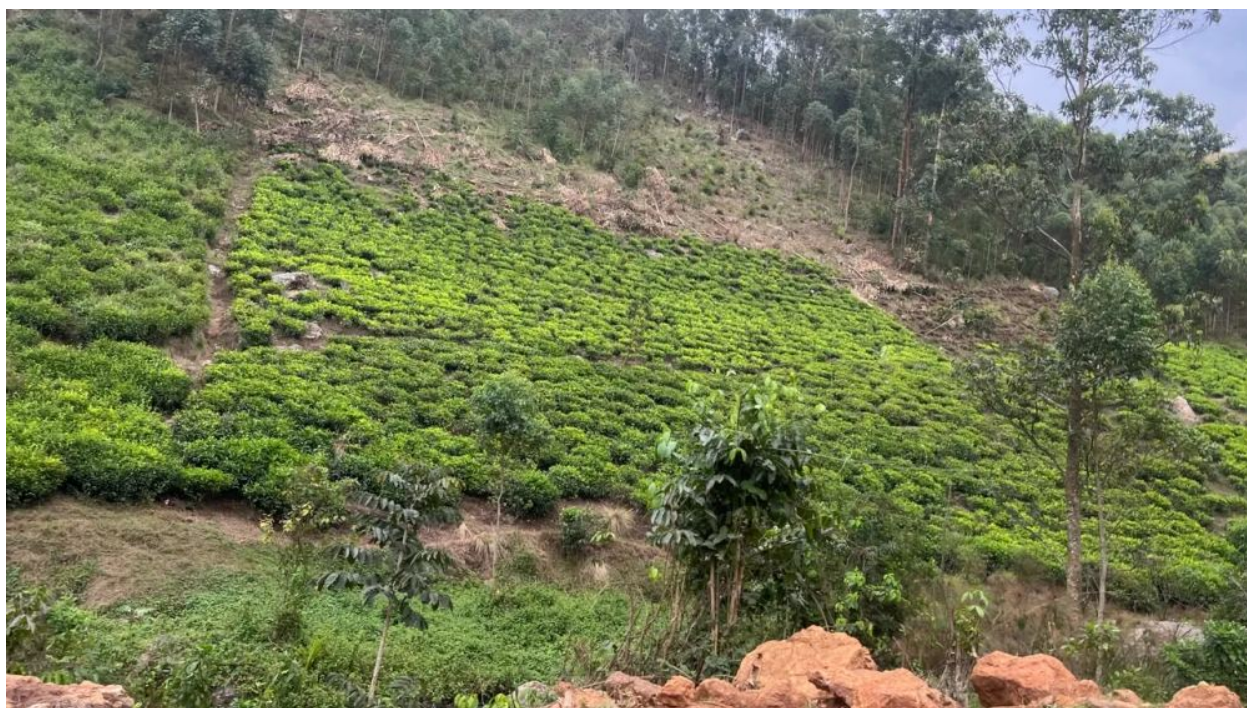
**5.4 Tea Growing** The supplied tea-plantation photograph shows tea cultivation on the Buhweju hills. Soil and water conservation is particularly important where cultivation occurs on steep terrain.

Tea planted to the ridge on a Buhweju hillside, eucalyptus and cleared ground above.

GPS-reference the principal springs and source points; protect springs, streams, riverbanks and wetlands from encroachment and pollution; maintain vegetation on steep slopes and around watercourses; promote soil and water conservation in tea, banana and other agricultural areas; promote environmentally responsible mining and control sediment from mining sites; prevent waste and contaminated materials from entering streams; restore degraded riverbanks, wetlands and erosion-prone areas; conduct periodic water-quality and catchment-condition assessments; strengthen community awareness and participation; and maintain photographic and geographical monitoring records.
